Fraunhofer-Institut für Zerstörungsfreie Prüfverfahren IZFP

As a result of the ongoing Franco-German collaboration project "FilameNDT", the one-sided access testing platform "FluxCrawler" for the flux leakage inspection of steel wire ropes was developed at Fraunhofer IZFP (figure 1). This testing platform is applicable to most types of wire ropes, requires a minimum diameter of just 3-4 cm and employs a caterpillar-like motion mechanism which combines the motion around and along the wire. The platform contains a strong permanent magnet which serves as magnetizer for the flux leakage inspection and attracts the inspection platform to the wire rope. A low-power electronics board performs the scanning process and controls the caterpillar motion. The platform is powered by a Lithium polymer battery which is sufficient for hours of operation. The magnetic leakage field which indicates imperfections and flaws in the wire rope is scanned with high lateral resolution, the resulting data are transferred to a mobile controlling PC via a fast long-range Bluetooth connection. The expected testing results will be similar to the ones shown in figure 3, delivering a vivid image of the leakage fi

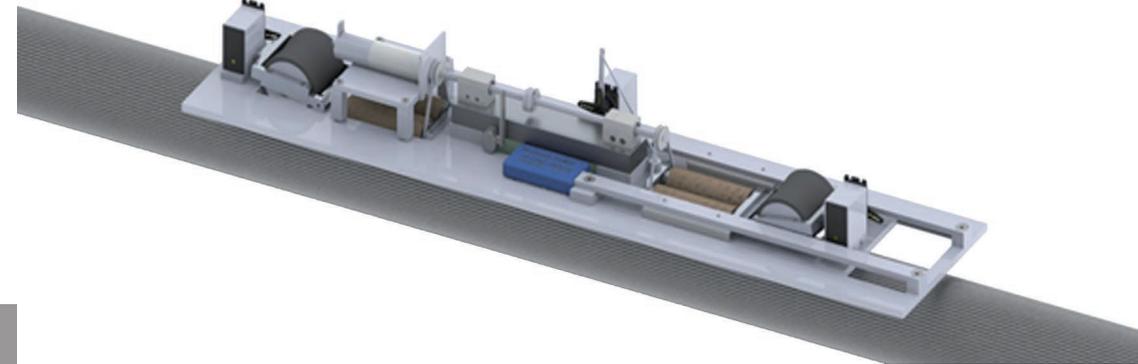
CAD model of FluxCrawler on a wire rope

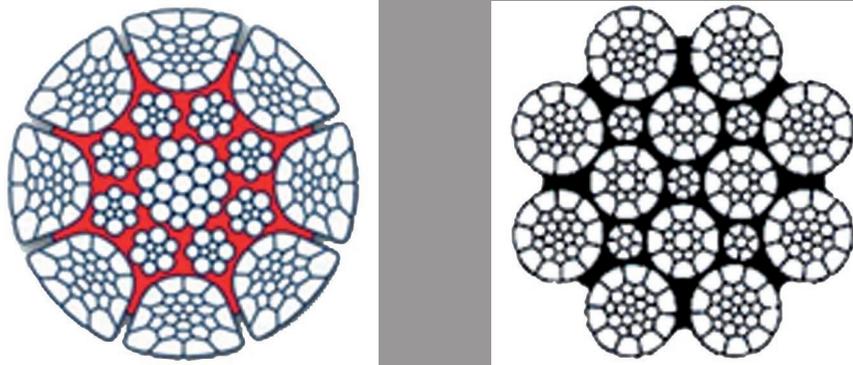
Different types of wire ropes, possible damage (scheme)

Regarding the on-site inspection of wire ropes, we are facing a large variety of rope constructions, dimensions and possible damage scenarios (figure 2). Existing testing systems which use the magnetoinductive or flux leakage method for the detection of cracks and filament ruptures are optimized for certain wire diameters, often do not offer precise localization of flaw indications, and require main power or heavy controlling equipment which restricts the on-site application.

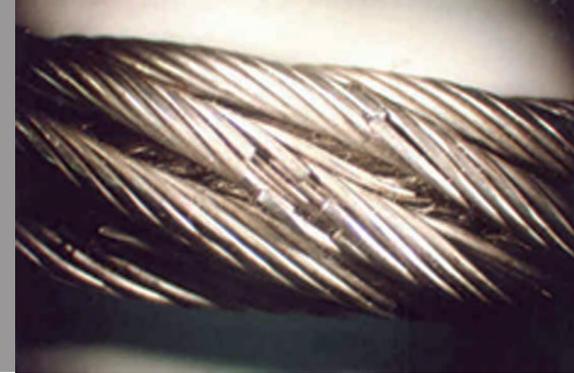
Damaged wire rope (optical image)

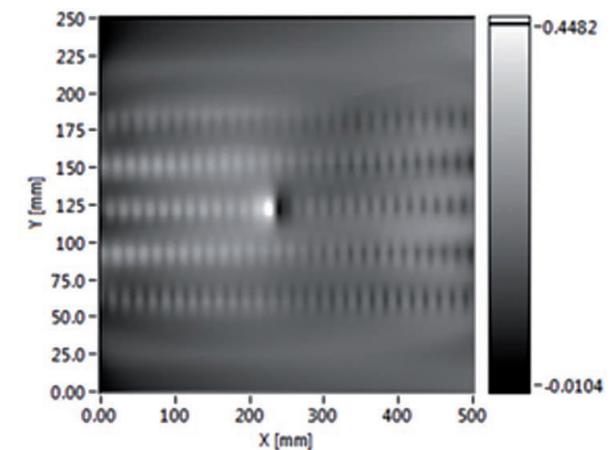
Typical flux Leakage signal of localized damage in submerged steel
