Fraunhofer Institute for Nondestructive
Testing IZFP

Sensor and Data Systems for Safety,
Sustainability and Efficiency

Magnetic flux leakage inspection

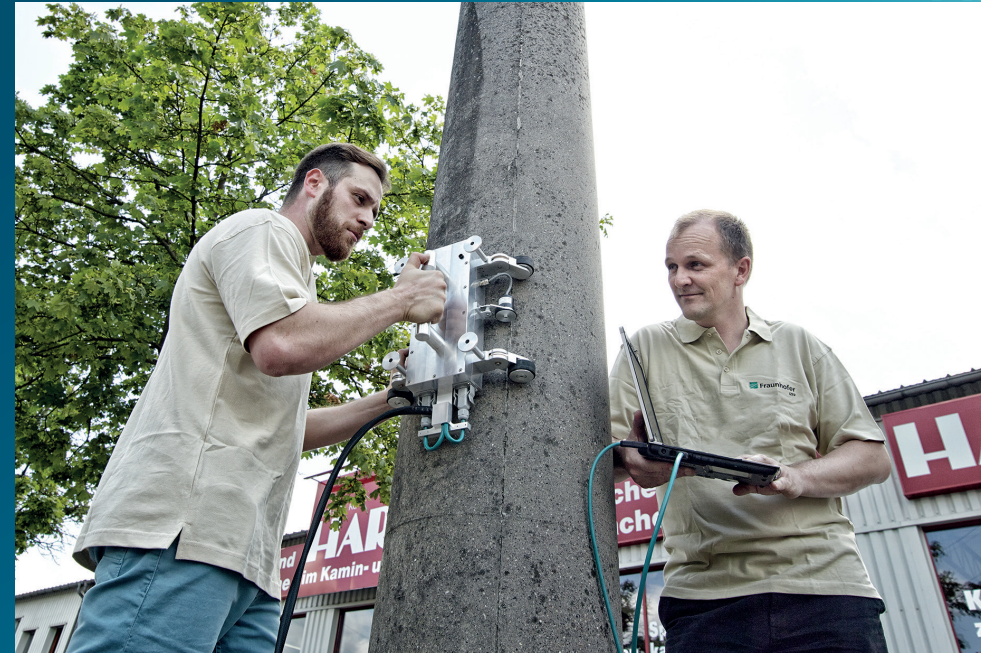
- Crack detection in the field of the industrial production of ferromagnetic components (eg. after induction hardening or after adjustment, fig. 3)
- Detection of wire breaks in prestressed concrete poles by BetoFlux system (cover picture)
- Check for internal and external defects on pipelines for corrosion detection (fig. 4)
